U.S. 101 MP 142.48 HARLOW CREEK (WDFW ID 990548): Preliminary Hydraulic Design Report

U.S. 101 MP 142.48 Harlow Creek
Preliminary Hydraulic Design Report
~~January~~~~September~~~~October~~ 2020 ~~12~~

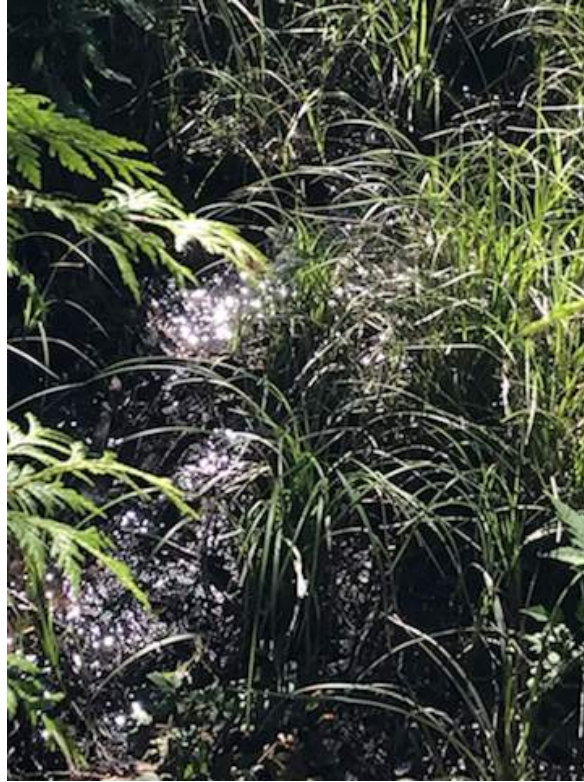
Sedges and brush are abundant on both banks. The banks are low, approximately 1 foot in height, and the channel is not well defined (Figure 7).

Figure 7: Substrate of upper Mainstem Harlow Creek Upstream from Confluence

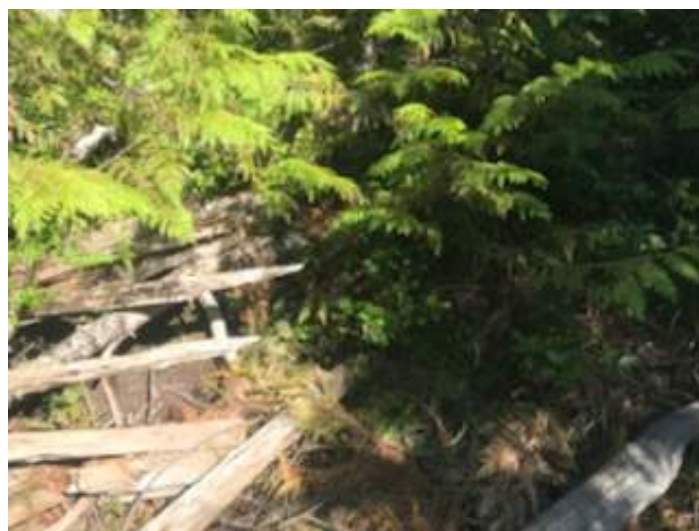
Figure 8: Large Woody Material (-LWM) from historic logging

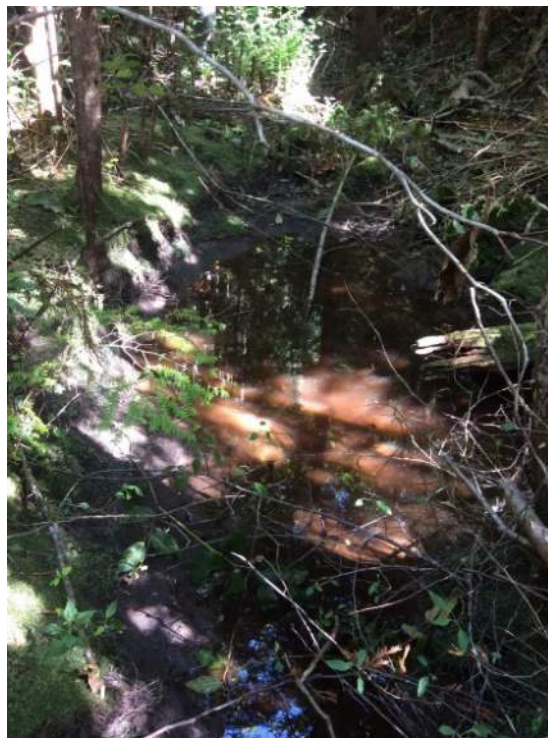
Where the flow converges on the downstream side of the island, there is a large log jam consisting of logs associated with historic timber harvest. Downstream of the jam, the channel narrows to approximately 150 feet wide. The substrate in this area is mostly fines with some gravels and cobbles. Sedge and brush grow in and over the channel in this reach. The bank slopes are gradual and about 2 feet tall, and are made composed primarily of silt and fines material. Stands of young trees grow on the banks. The banks are undercut, and the floodplains are flat and accessible (Figure 13 and Figure 14). Natural Logs help form and shore up the banks periodically.

Figure 13: Stream conditions downstream of confluence

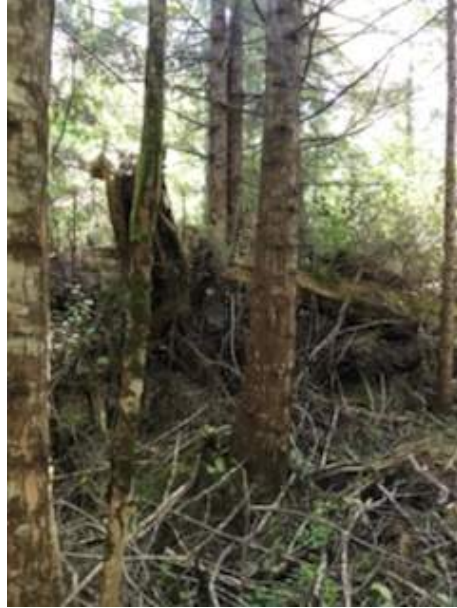
Figure 14: Floodplains downstream of confluence

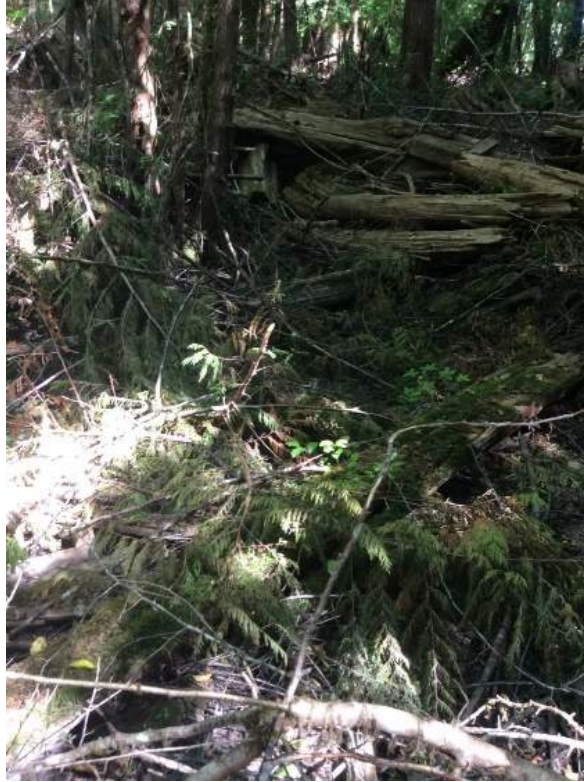
Figure 16: LWM accumulation near exit of pool

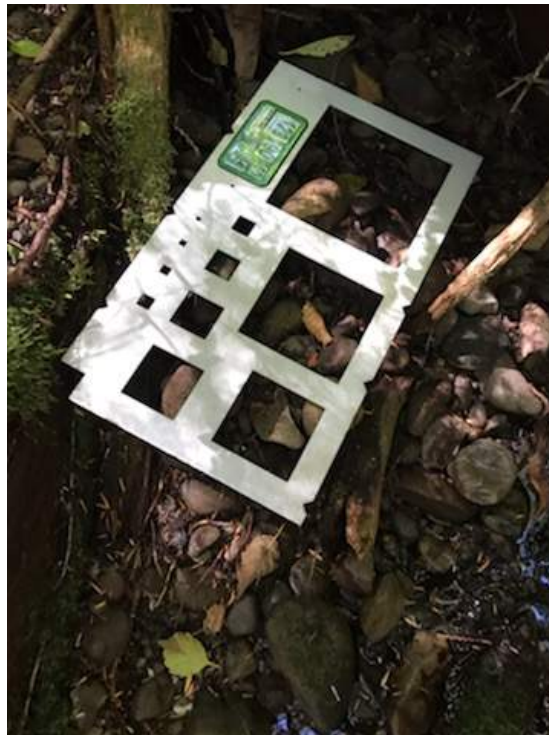
Downstream of Past the logging wood LWM at the exit of the pool, there is a large deposit of gravels and cobbles (Figure 17). The largest bed material found in this location was 4.5 inches in diameter.

Figure 17: Substrate downstream of LWM near exit of pool

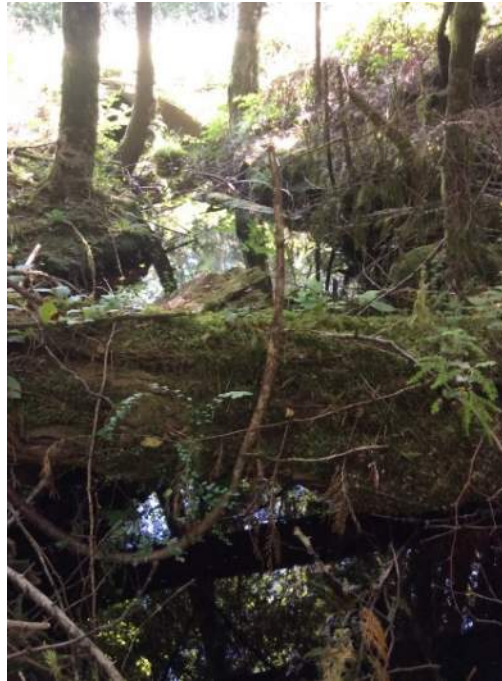
The substrate from this section downstream to deposit up until the culvert inlet is primarily gravels. From this spot to the culvert a Approximately 50 feet upstream of the culvert inlet away, LWM recruited naturally from the banks is present in the channel and lying across bankfull and forming accumulations that span the channel between both banks (Figure 18). Valley occlusion has led to some areas where logs are quite dense and accumulating soils, supporting tree and shrub growth, which the stream flows and pools beneath. The area is characterized by a complex of multiple flow paths and sloughs.

Figure 18: Stream conditions between LWM and inlet

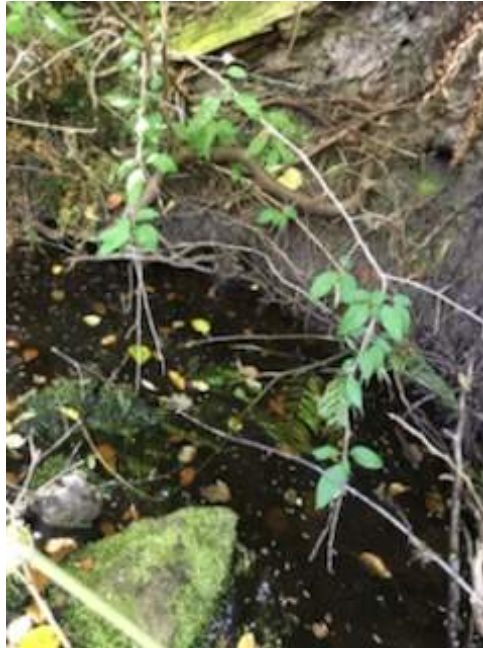
The channel shape in this area consists of short vertical banks that slope up towards a flat floodplain. The banks are undercut in the proximity of the culvert and confine the channel in a straight, entrenched planform (Figure 19). Flow contraction due to an undersized culvert is likely driving localized channel bed and bank erosion at the existing inlet. Natural Naturally recruited logs shore up the banks provide a degree of bank stability in the stretch area reach between the racked-up logging wood and the culvert. On the right bank near the culvert, a small side channel enters the channel stream. It likely carries floodplain flow from upstream to this location. There is LWM present in the side channel.

Figure 19: ~~Incision~~ Bank erosion near culvert inlet

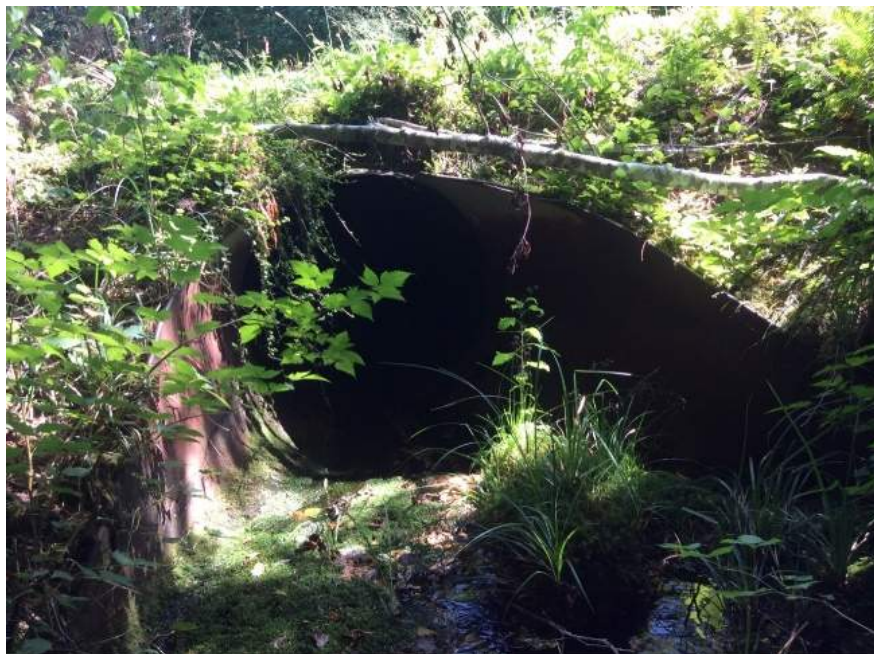
The culvert itself is a ~~4-foot wide~~ 4-foot-wide CMP mitered to slope (Figure 20). The culvert inlet is perched approximately 4 inches above the channel bed.

Figure 20: Culvert inlet

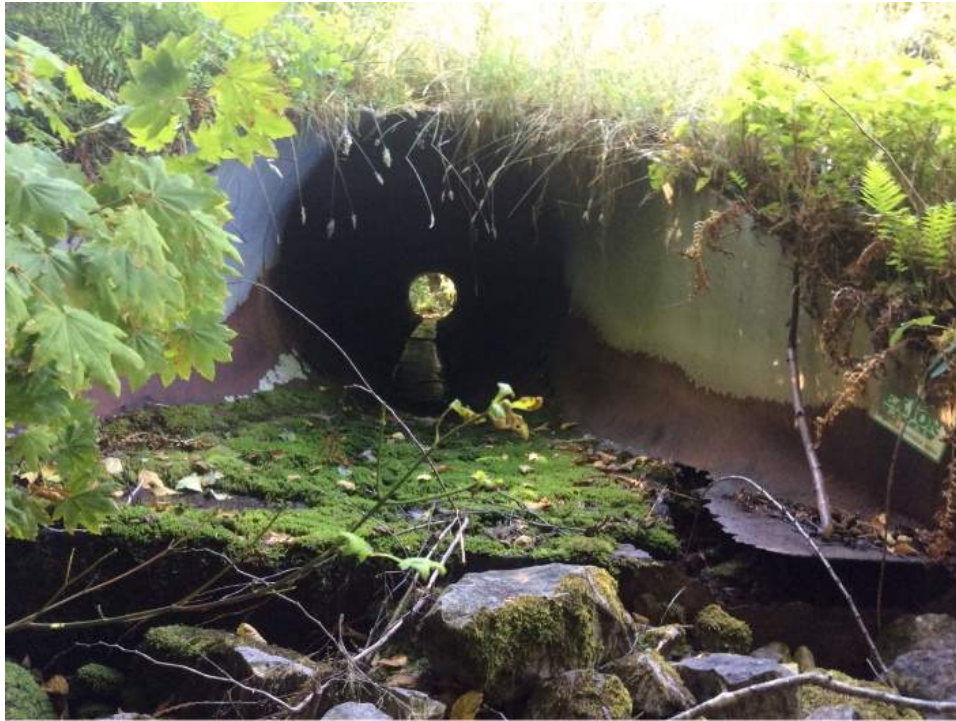
At the outlet of the culvert, there is an approximate ~~water level drops approximately 6 inches drop~~ from the culvert apron on below to rip-rap which lines the channel bed (Figure 21). The existing metal apron is failing due to corrosion and past undermining at the transition to the channel. Rip-rap is present in the channel for 15 feet downstream of the culvert.

Figure 21: Culvert outlet

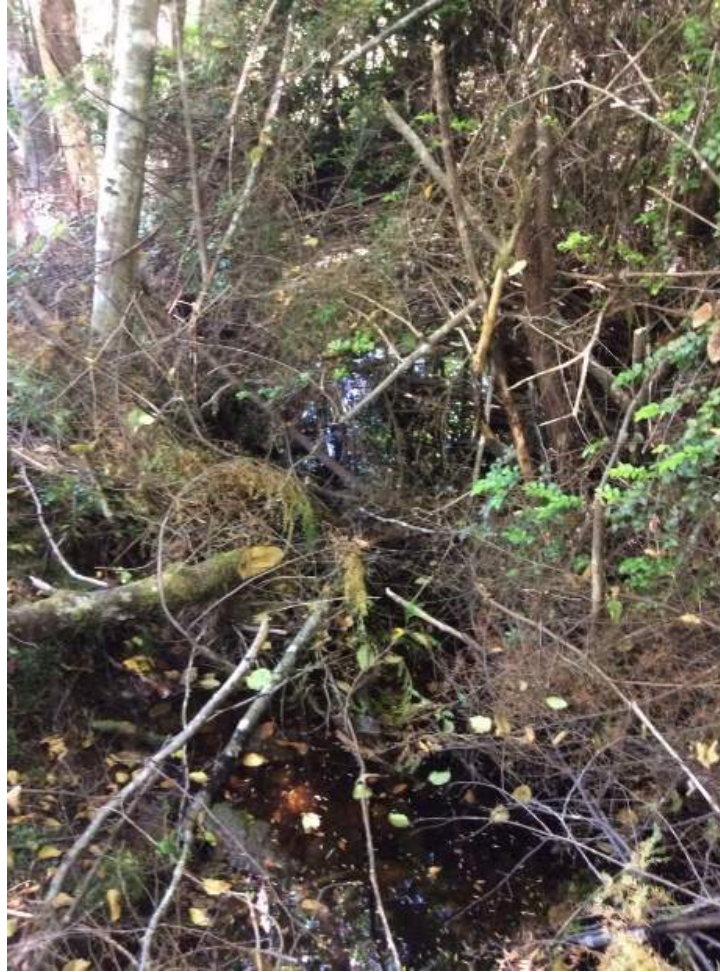
The right bank is about 3 to 4 feet tall, while the left bank is lower with an accessible inset floodplain surface. Stands of young trees and ferns grow on the banks. Some undercutting of the channel bank is present at a bend downstream of the rip rap. Small debris and brush is-are racked up after this bend, throughout the whole of the downstream reach. All LWM debris observed within the channel appears to be a result of natural recruitment along the banks and was not indicative of logging presence, though the pieces and accumulations are not stable enough to provide a lasting influence on channel form or processes (Figure 22).

Figure 22: Brush and debris in channel

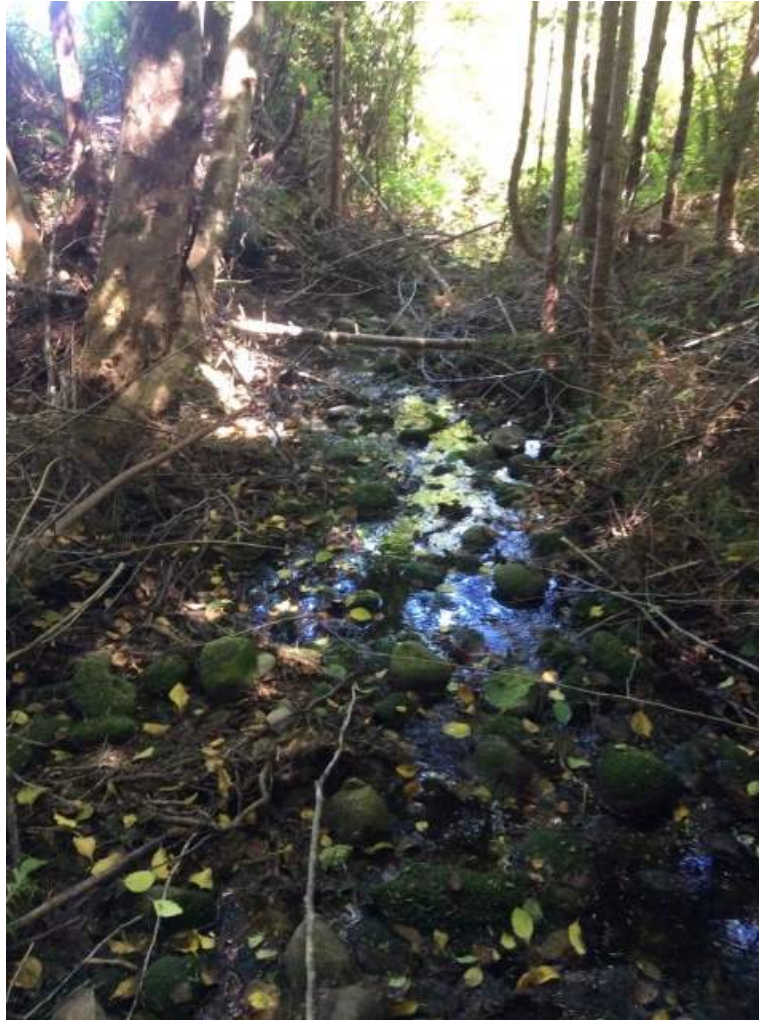
The reference reach begins downstream of the racked LWM roughly 45 feet downstream from the culvert outlet. ~~Downstream of the LWM racking, the reference reach begins~~ (Figure 23). The left bank is ~~slightly lower than the right,~~ about 1 ~~to~~ -2 feet tall ~~while and~~ the right bank is about 2 ~~to~~ -3 feet tall. The left bank floodplain is flat before sloping up to the roadway. The right floodplain is moderately sloped. Roots of trees form the banks periodically on both banksides of the channel. The channel itself is 4 to 5 feet wide, and flat, with no clear thalweg and entrenched within its near vertical banks, owing to the influence of the undersized culvert opening. This channelized section is armored and relatively stable, as evidenced by the establishment of moss on top of streambed cobbles.

Figure 23: Reference reach

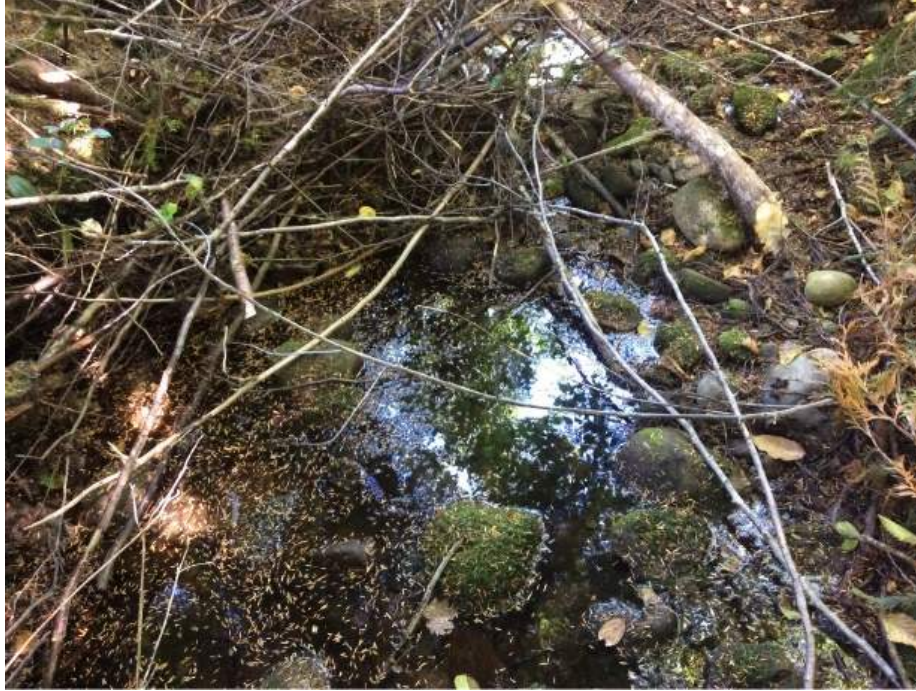
Figure 24: Reference reach substrate and pebble count location

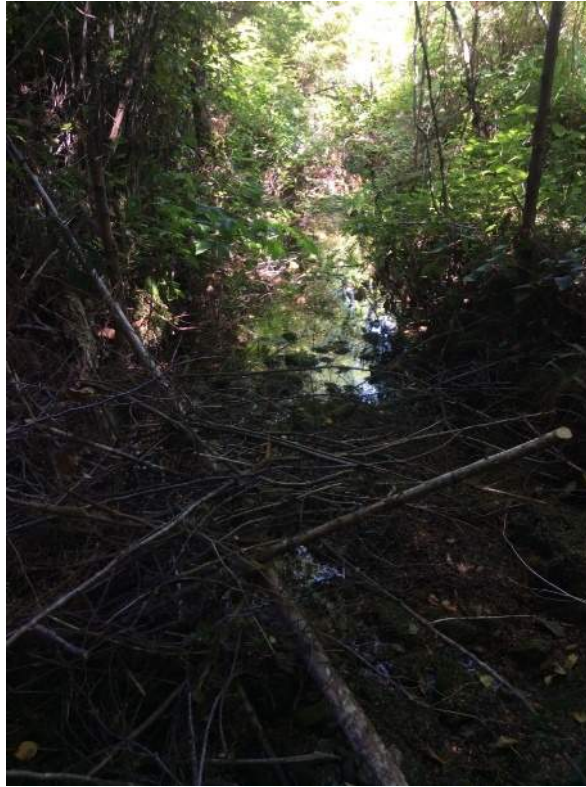
Downstream of the reference reach, the channel shape changes to become narrower and deeper with inaccessible floodplains (Figure 26). Both banks are 3 to -4 feet in height and show signs of erosion due to channel incision (Figure 27). The banks are vegetated with brush and trees, and the substrate is gravels and cobbles.

Figure 26: Typical channel conditions downstream of reference reach

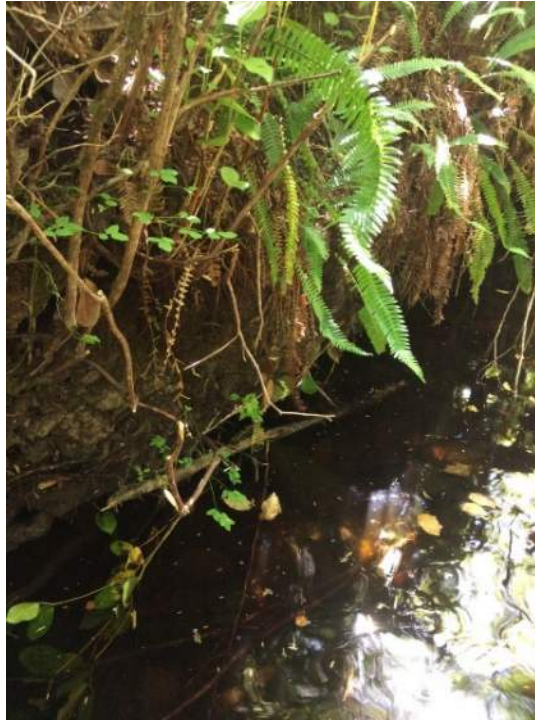
Both banks are 3-4 feet in height and show signs of erosion due to channel incision (Figure 27). The banks are vegetated with brush and trees, and the substrate is gravels and cobbles.

Figure 27: Channel incising and undercut bank

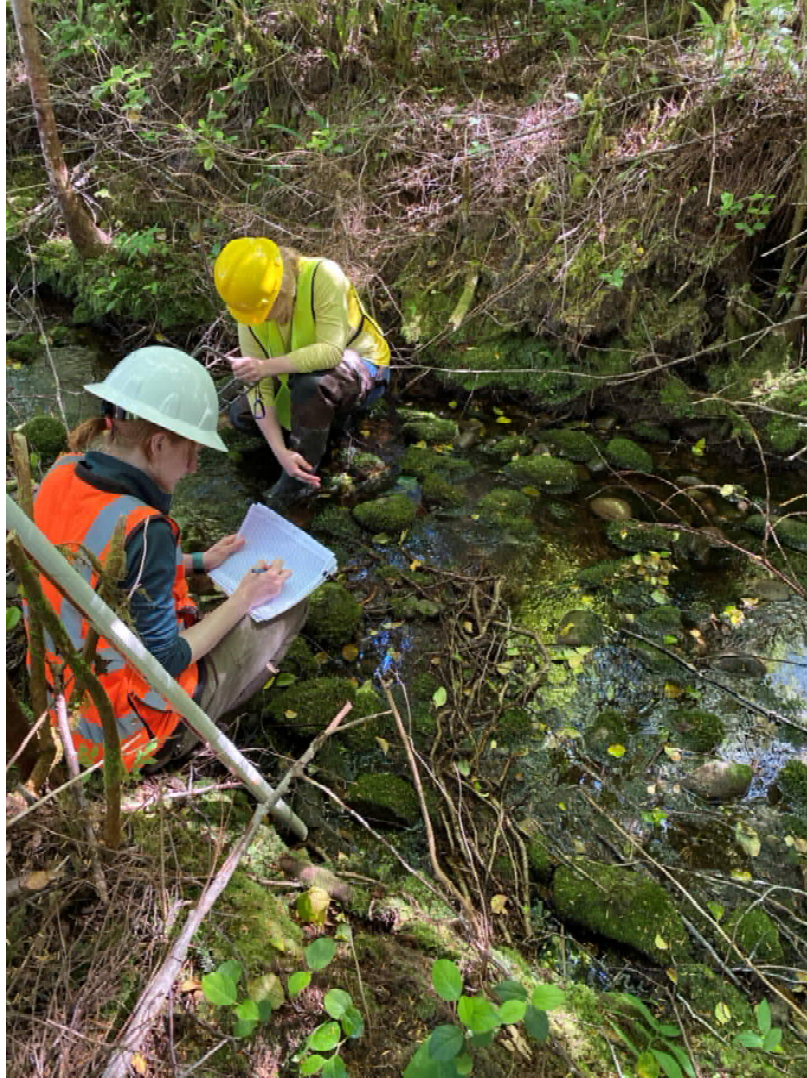
A section of stream approximately 45 feet downstream of the culvert (Figure 29~~Figures 29 and 30~~) was chosen as the reference reach, because ~~it is most representative of a naturally occurring streambed,~~ with it has the least amount of anthropogenic influences within the surveyed limits. This reach has an approximate average channel gradient of 1.5 percent. A pebble count was conducted at the reference reach. ~~Figure 30 shows the location of the reference reach.~~ This reference reach was used primarily for proposed design channel shape and comparison to proposed hydraulic results throughout this Preliminary Hydraulic Design (PHD) Report, as the entire upstream reach was influenced by ~~copious an~~ unnatural amounts density of LWM from historic logging activities. While the reference reach is not completely outside of the area of influence from the existing culvert and road prism, and shows signs of degradation, its selection is acceptable for BFW measurement and channel design.

Figure 29: Typical segment of Reference reach looking downstream on June 25, 2021. Flow direction is from right to left of photo.
